Full Adjusted Appraisal

Income Valuation

Boeing 757-200 Aircraft,

Serial Number 12345,

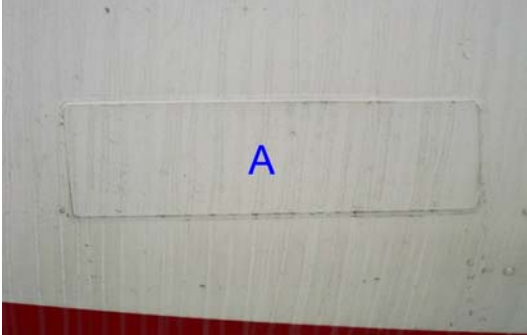
Repair A is a 24x7 inch external repair doubler located on the left aft fuselage at BS 640 aft of the cargo door and below the cargo floor line. The repair had sealed edges and was installed with solid flush head fasteners. The repair appeared to be of good quality workmanship.

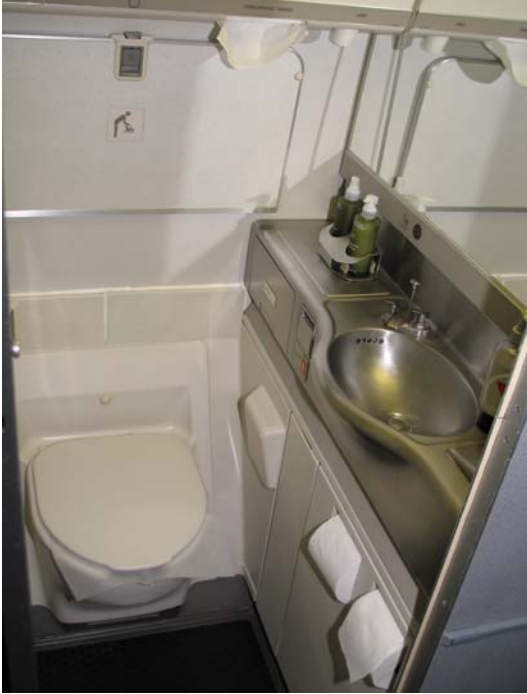
The aircraft had fourteen (14) lavatories located throughout the aircraft cabin. All lavatories were clean and free of any odors. The lavatory floors are firm and show no evidence of fluid leaks. The lavatories feature recirculating type flush toilets. Several of the lavatories had loose trim pieces around the lower toilet structures. All of the lavatories had smoke detectors with appropriate warnings, information placards present in appropriate locations and trash receptacles that were properly

taped to maximize fire retarding capabilities. The cabinets, ceiling and side wall panels as well as the toilet shrouds were in very good condition.

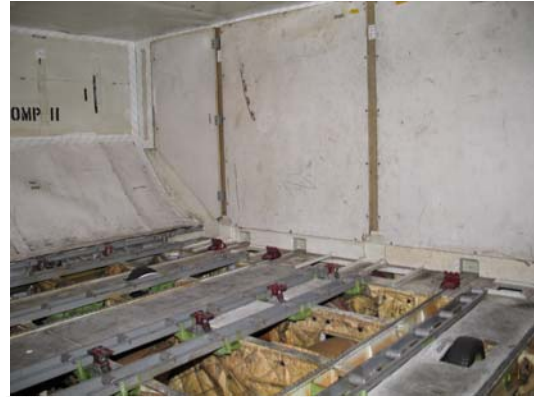
Overall the cargo/baggage compartments were in good condition. The compartments show the typical minor dents and scuffing inherent of an “in-service” aircraft. No evidence of moisture, corrosion or fluid leaks was

found. The sidewall and overhead panels were secure but did show some minor wear and scuffing.

1.	Lower fuselage of aircraft needs cleaning.
2.	Repair Elevator PCU minor leak and Investigate / clean white substance on lower aft empennage belly.
3.	Repair right aileron leak, and minor leaks in the engine pylon and landing gear wing root areas.
4.	Replace sealant on and around the engine panels
5.	Replace cockpit sheepskin seat covers.
6.	Clean / replace bulkhead material and repair the disbonding in the exterior bulkhead covering.
7.	Repair the seam in galley floor pad.
8.	Replace Mid-cabin Lavatory mirror and recover or paint the door.
9.	Replace cargo compartment tape with required fireproof tape.

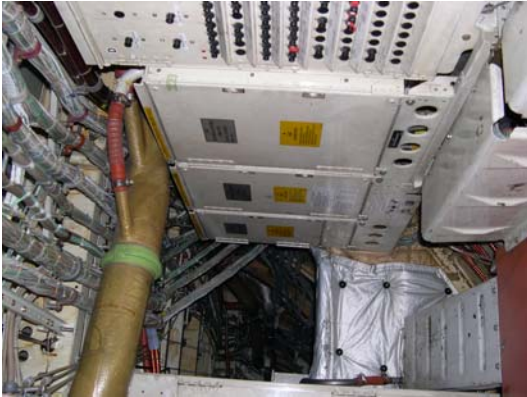
The electrical and electronic equipment (E&E) bay was inspected and an inventory of the installed equipment was accomplished. This inventory can be found in the “Aircraft Technical Specifications” section of this report.

All equipment was properly installed and all electrical lines appeared to be properly routed and secure. The visible overhead floor beams and side wall structure appeared to be covered with insulation/sound proofing blankets, properly taped and sealed.
